Department of Water Resources

BULLETIN No. 116-5

THE ALASKAN EARTHQUAKE

OCTOBER 1965

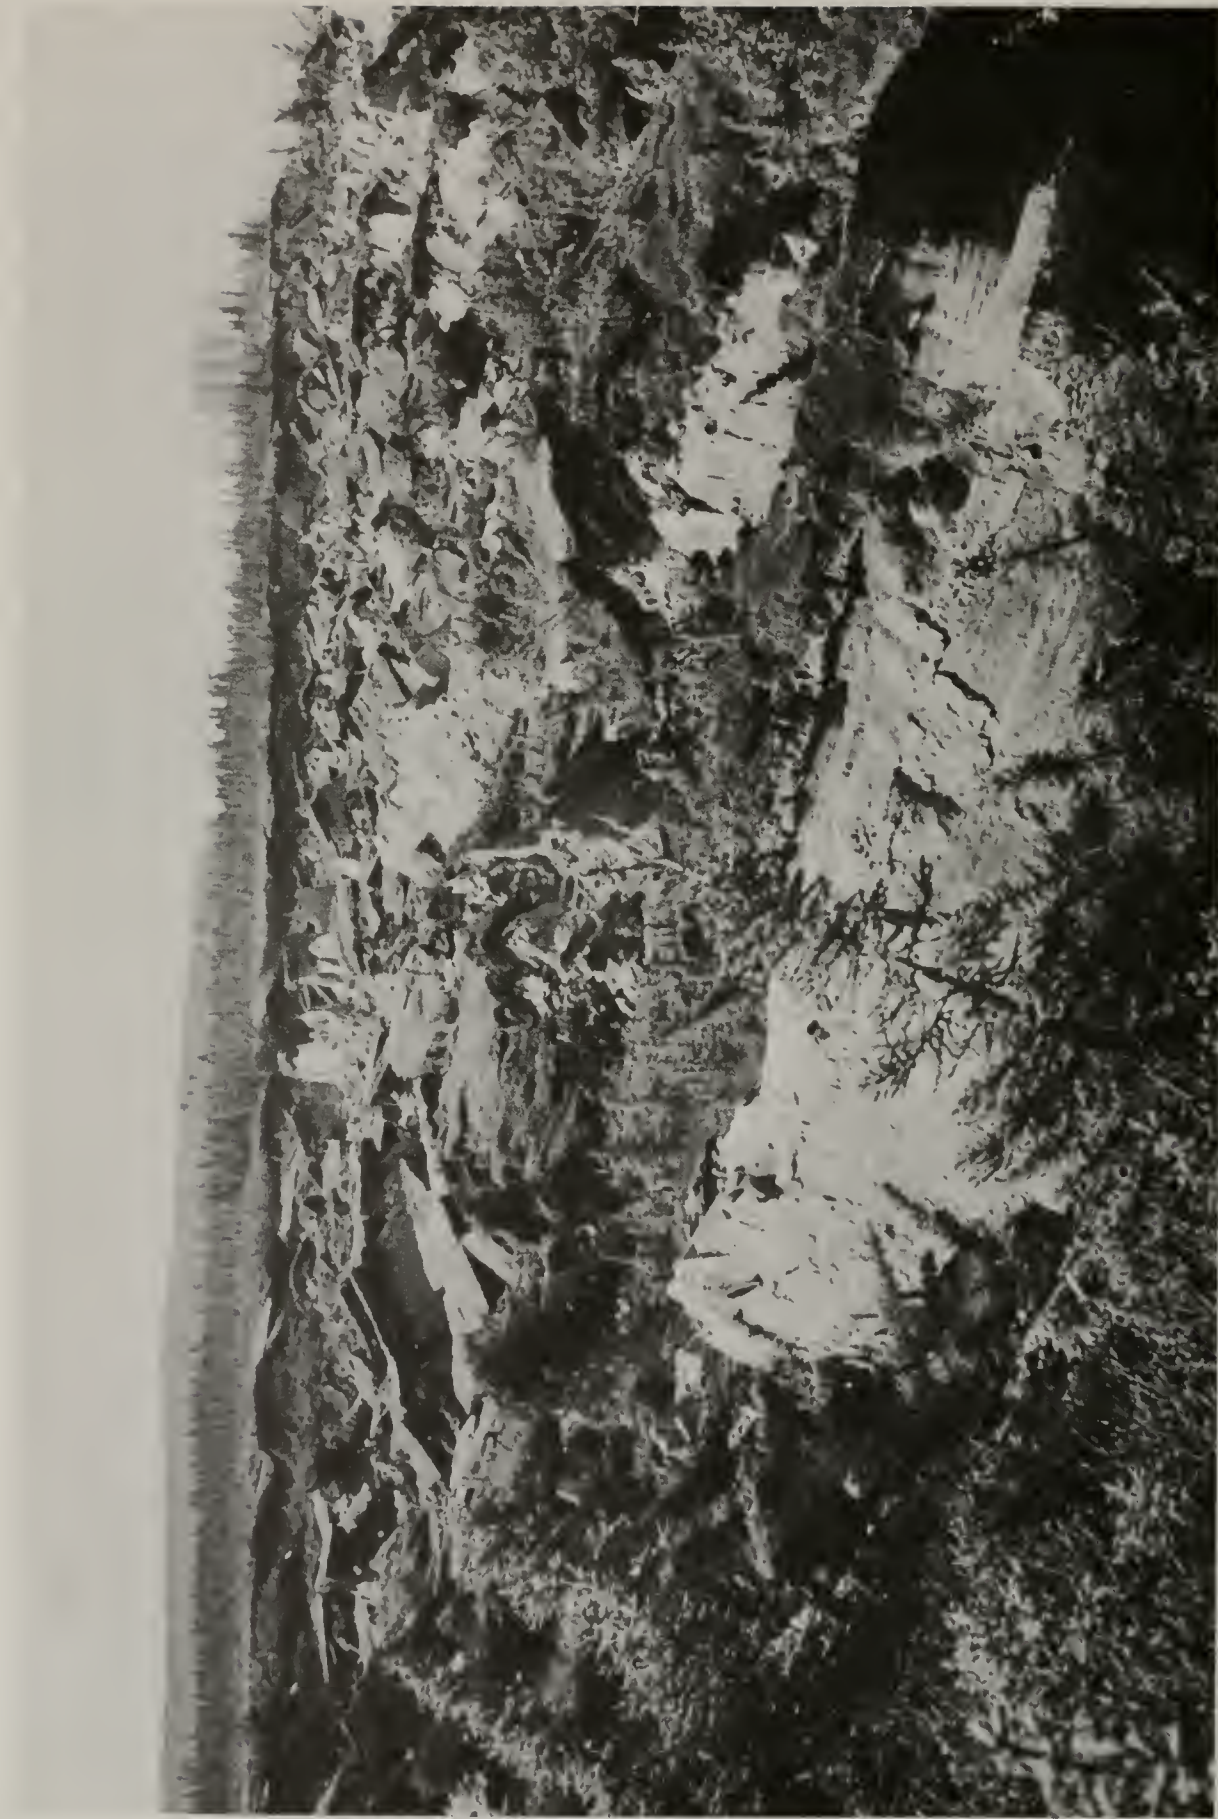
The Turnagain landslide, Anchorage, Alaska

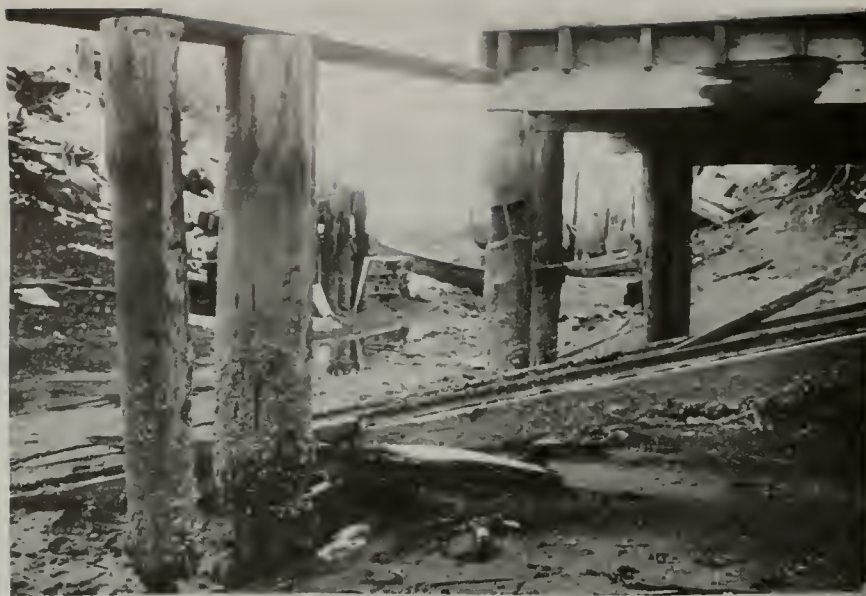
Illustration 1. Inlet to small boat harbor at Cordova. Picture was taken at high tide and shows result of tectonic uplift on coastal communities.

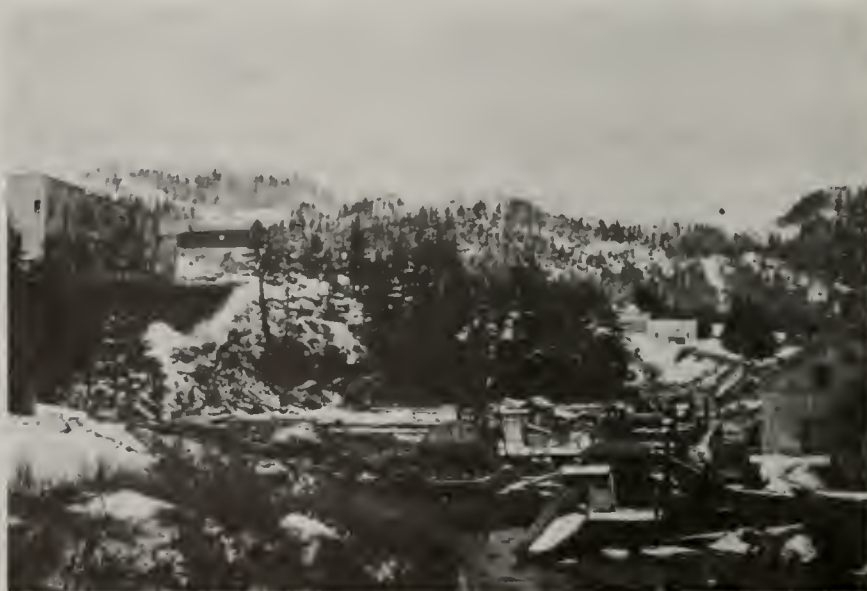
Illustration 2. Inner harbor at Cordova during high tide.

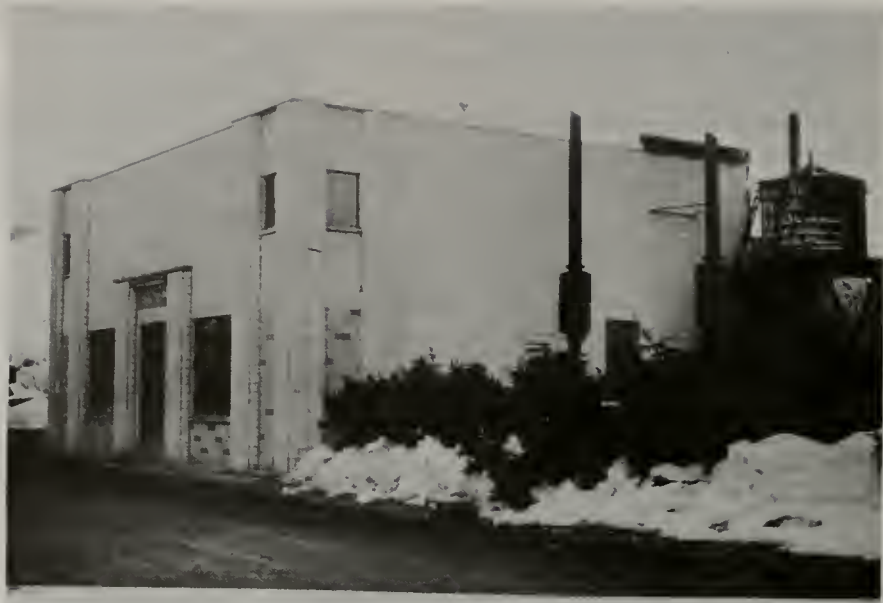
Illustration 3. Meals building in Valdez
(power plant). No damage.

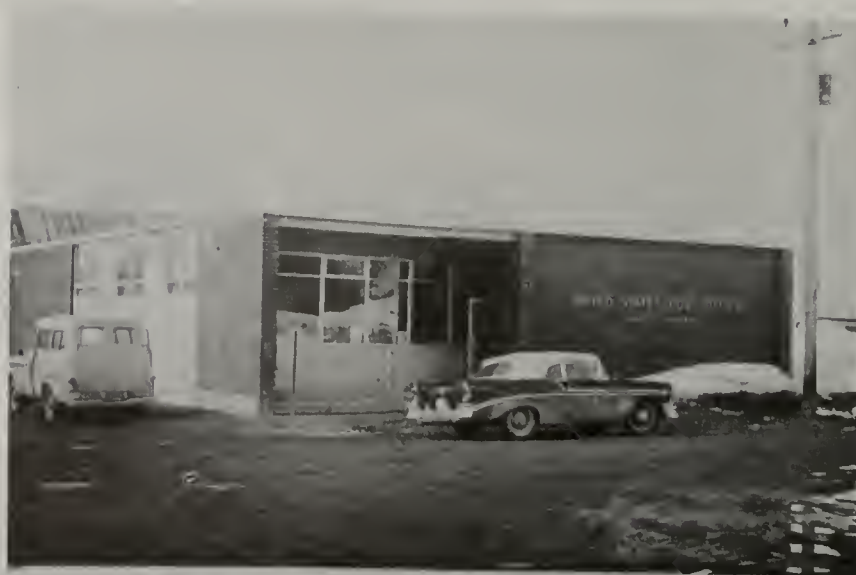
Illustration 4. Post Office in Valdez.
No damage.

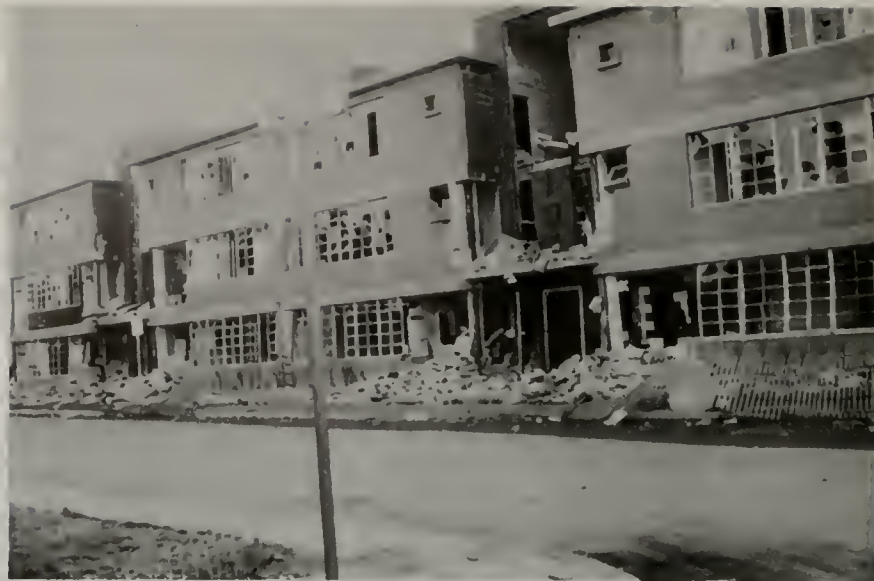
Hollow concrete block was a common building material used for commercial and industrial structures as well as apartment houses. Much earthquake damage occurred to structures using this type of construction material, because (1) as shown in Illustration 5, there was insufficient reinforcement, or no reinforcement at all to resist seismic forces, and (2) there was insufficient overlap of reinforcement steel to transfer stresses from one bar to another.

Illustration 5. An apartment building in Anchorage constructed mainly of hollow blocks. The damaged blocks showed apparent lack of reinforcement to resist lateral deflections.

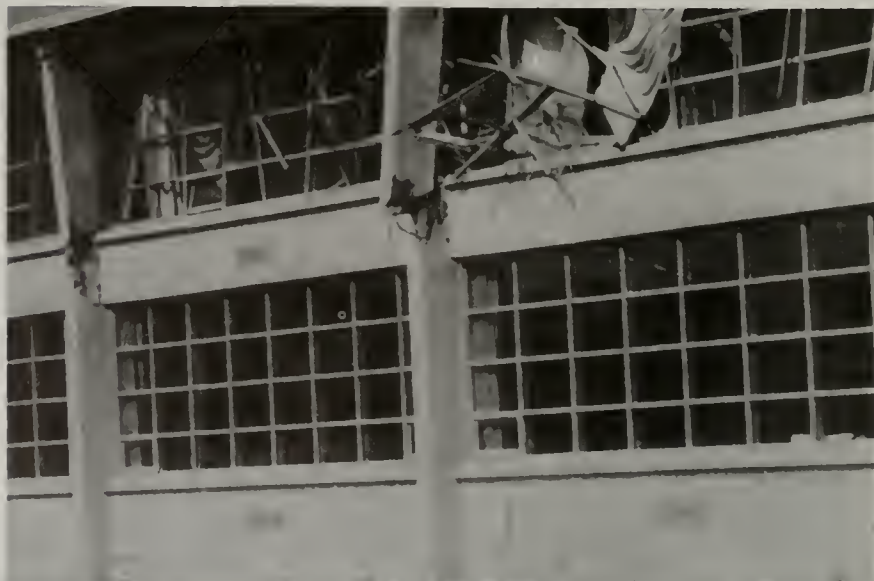
Illustration 6. Structural failures due to insufficient reinforcement steel and concrete area.

critical areas. Some column failures indicated columns were inadequately designed for compressive strength and had insufficient reinforcement or concrete area.

In other instances, lack of reinforcement and concrete area in column connections to floorings or roofs did not permit the columns to transfer the moments or shear structurally, resulting in fractured columns. This type of failure occurred at the West Anchorage High School. Illustration 6 shows failures resulting from insufficient reinforcement steel and concrete to resist the lateral shear forces.

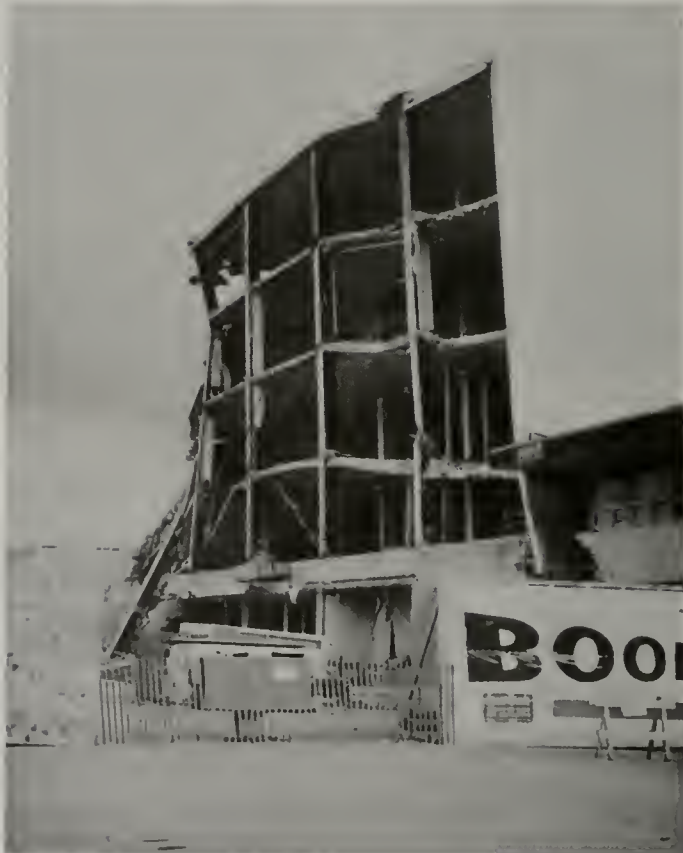
In the J. C. Penney Building, precast panels were connected to the steel frame as an exterior wall. During the earthquake, connections between these panels and the steel frame failed when they could no longer restrain the deflections of the frame. This failure was due to the difference in relative stiffness of the two elements and the error in designing the structure to act as a homogenous system to resist lateral forces dynamically. See Illustration 7.

Illustration 7. The J. C. Penney building
in Anchorage.

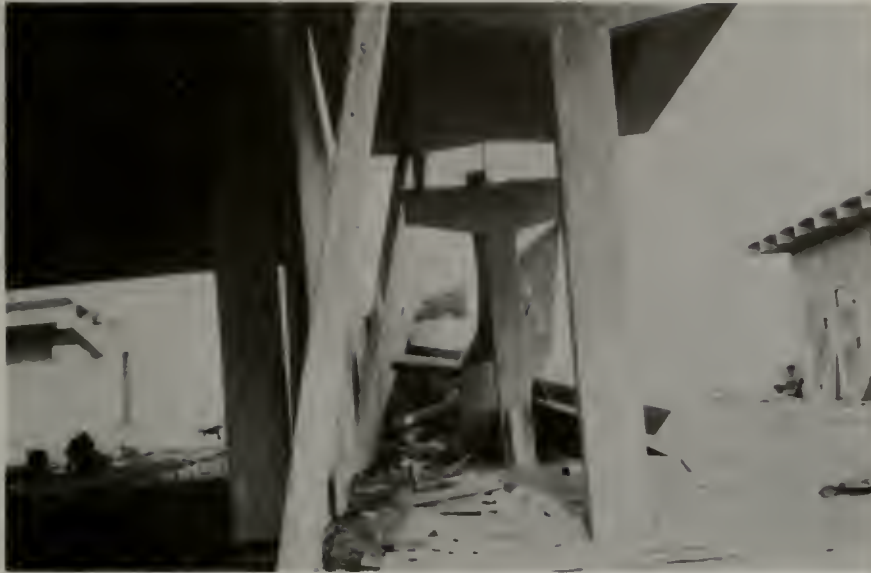
Another type of design failure resulted from inadequate connections between precast elements. A good example was the Alaska Sales and Service Building which was constructed of precast panel walls, and precast "T" beam roof resting on precast reinforced concrete bents. Interconnections between the precast elements were made by means of welded metal connections. After the earthquake, investigations showed that the connections failed causing the walls to collapse or tilt out of plumb. See Illustrations 8 and 9.

Illustration 8. Connection failure of precast members resulting in separation of wall from roof.

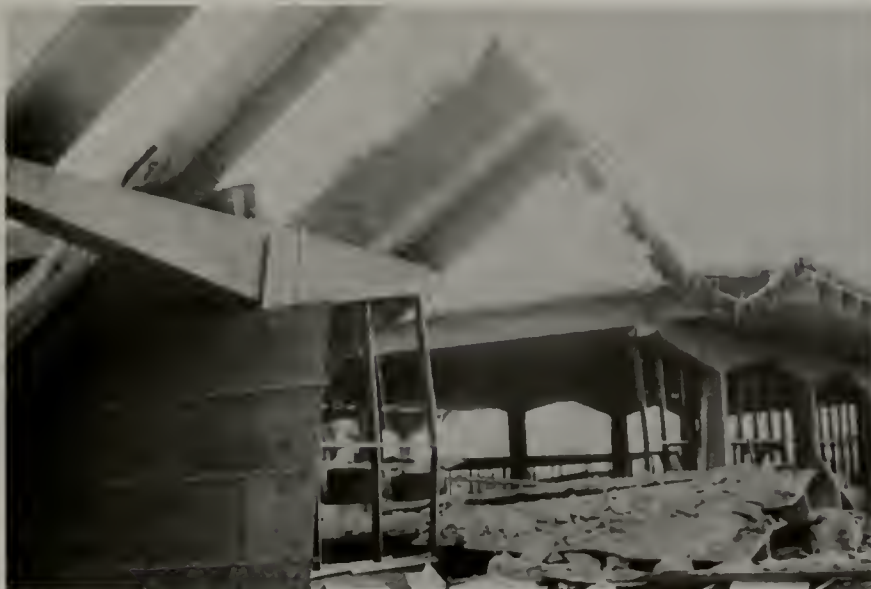
Illustration 9. The Alaska Sales and Service Building in Anchorage is a good example of damage resulting from defective connections in precast concrete construction.

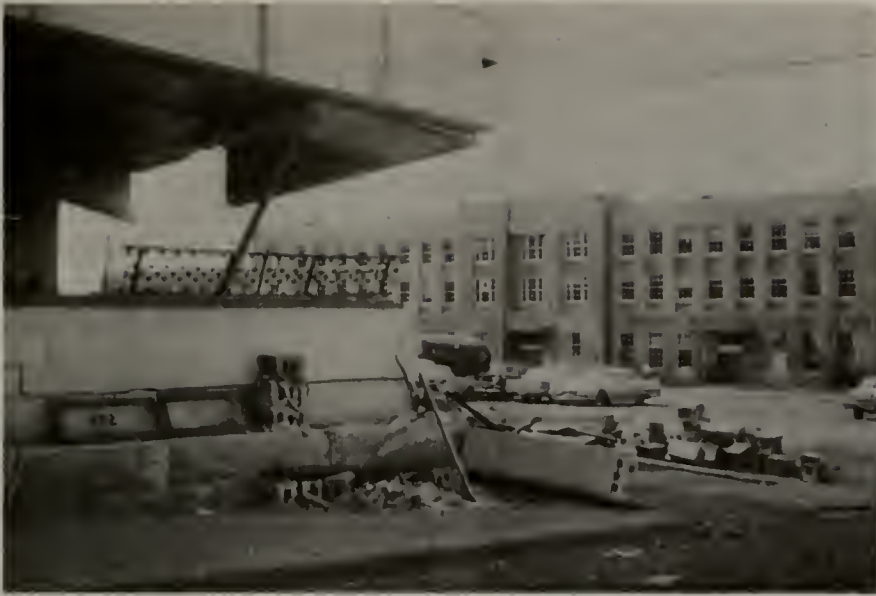
It is obvious that no matter how well a structure is designed by the engineer, his efforts will be wasted if the structure is not built according to his plans and specifications. Hollow concrete block construction, which was a common material used in structures in Anchorage, suffered greatly from failures that were attributed to faulty construction.

Illustration 10. Hollow concrete blocks showing lack of grout in cells.

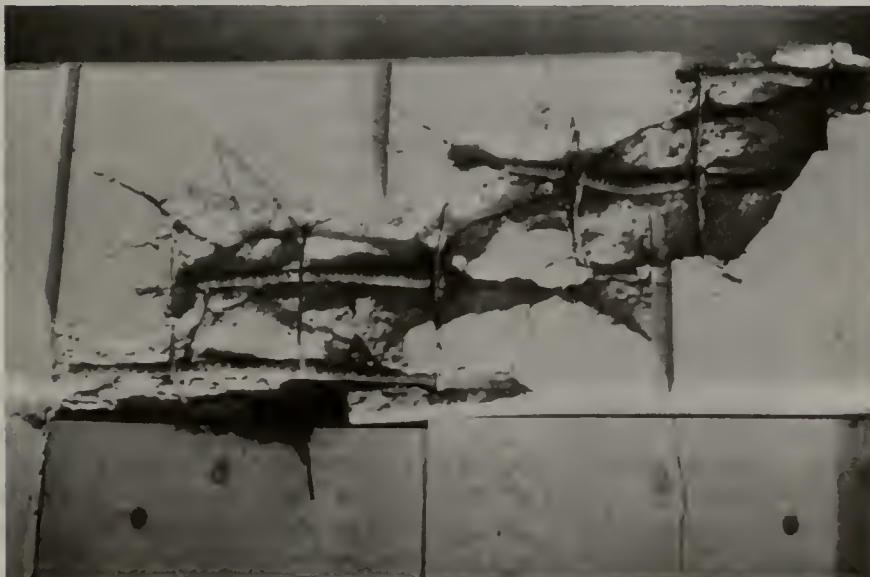
Improper concrete mix in some reinforced concrete structures resulted in the concrete possessing inadequate compressive strength. Failure occurred when the concrete could no longer withstand the loads resulting from the vibration and causing the concrete to bulge out or "mush out" in a manner similar to column failures resulting from insufficient ties. The plasticity of the concrete caused the tremendous load to be transferred to the reinforcement steel, resulting in a bending failure of reinforcement. An example (showing column buckling of reinforcement steel) is shown in Illustration 11.

Illustration 11. Compression failure due to inability of reinforcement to sustain transferred load resulting from plastic flow of concrete.

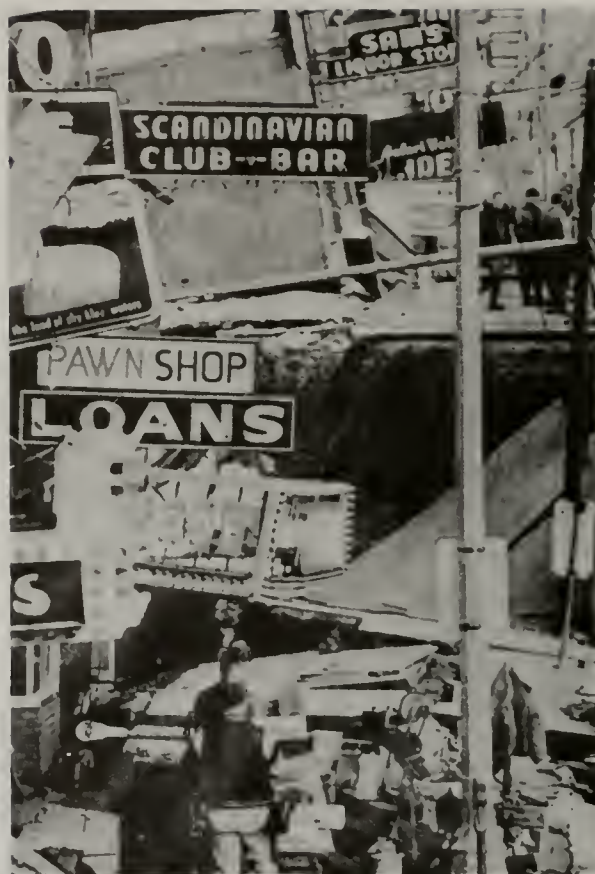
Illustration 12. Fourth Avenue
landslide in Anchorage.

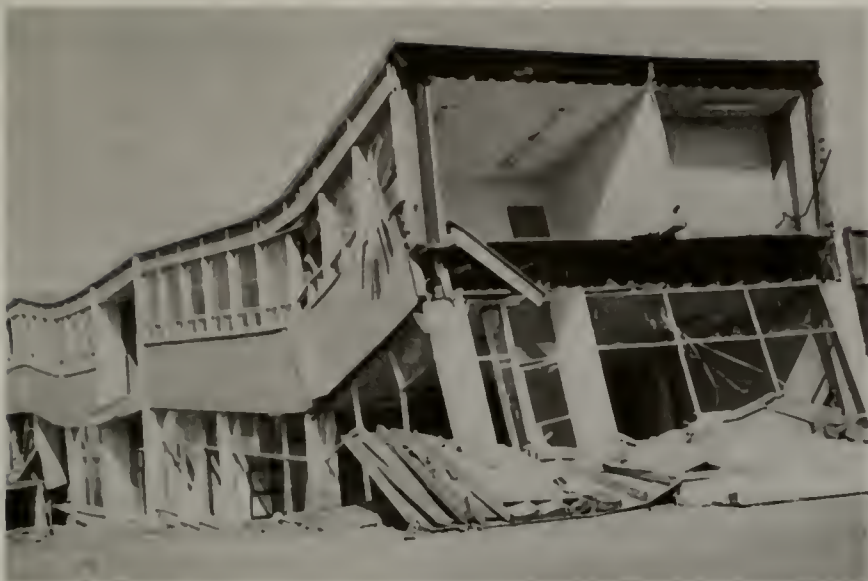
Illustration 13. Building damaged by movement of foundation.

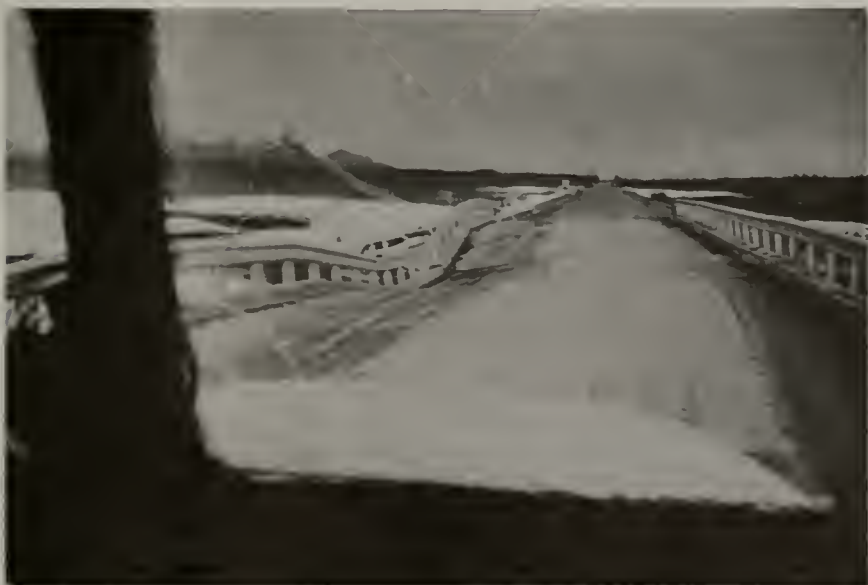
Illustration 14. Sag in highway fill near Cordova.

Damage from settlement of poorly consolidated glacial outwash and other types of alluvial materials were noted in a number of areas. The Copper River highway which traverses approximately 14 miles of bay mud and muskeg near the town of Cordova suffered much damage from settlement and lurching of highway fills on these poor foundation materials. Structures of the Eklutna Project were damaged by settlement of alluvial materials. Settlement of soil combined with tectonic subsidence lowered the seaport town of Homer Spit, causing inundation by the sea, and caused about 5 miles of the Alaskan Railroad to be inundated in the vicinity of Turnagain Arm.
